Controlled field evaluation on concrete bridge deck slab using NDT techniques

5.2. Evaluation of concrete bridge deck slab using IRT

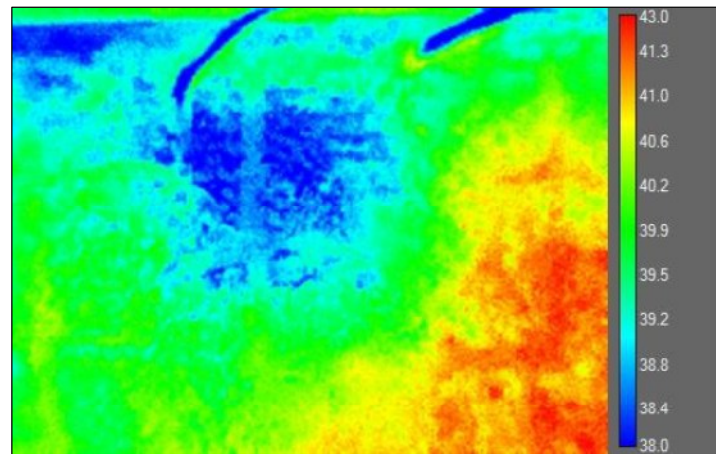
Figure 5.1. Delamination occurring as cool spot in raw thermal image during night-time cooling cycle

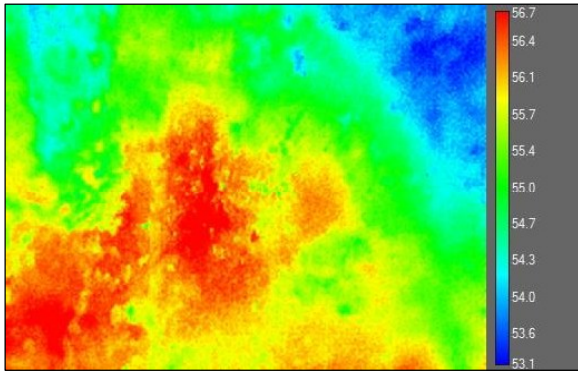
(a) DL-1/10/A

Figure 5.2. Raw thermal images showing fully detectable delaminations as hot spots taken during 11:00 am to 1:00 pm

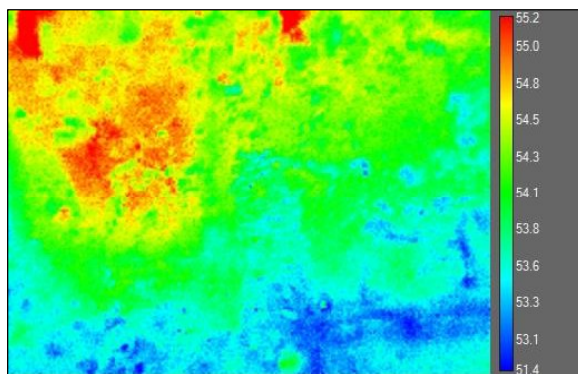
(a) DL-1/5/A

Figure 5.3. Raw thermal images showing partially detectable delaminations as hot spots taken during 11:00 am to 1:00 pm

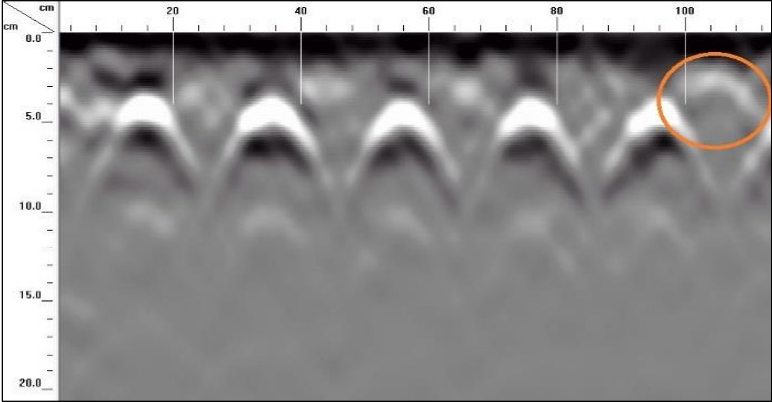
In general, continuous hyperbolic reflections of uniformly high magnitude with relatively short arrival times are characterized by areas of sound concrete with reinforcement mat. On the other hand, dull reflections with low amplitude, discontinuous hyperbolas, extra peaks, or apparent change in position of reinforcement indicating a change in arrival times due to difference in material, specifies signs of deterioration, and abnormality. Figure 5.6 shows the delamination DL-1/20/B (encircled) appearing over the top rebar with dull reflection, approximately at a distance of 100 cm from the slab end, as verified from the drawing. The bright hyperbolic reflections are obtained from the upper rebar of top reinforcement mat and the peak of the hyperbolas indicates the apex of these bars. Figure 5.7 shows the reflection of DL-2/10/A, appearing as an extra peak with low intensity of brightness than the normal rebar. Similarly, Figure 5.8 shows the reflection of DL-2/20/B.

Figure 5.6. Sectional profile showing reflection of DL-1/20/B

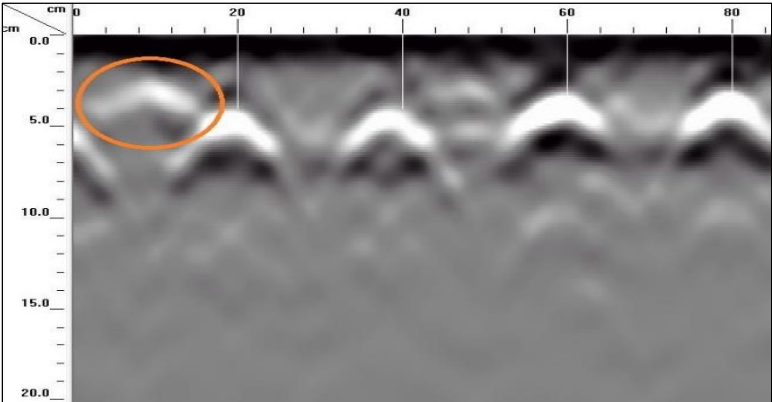
Figure 5.7. Sectional profile showing reflection of DL-2/10/A

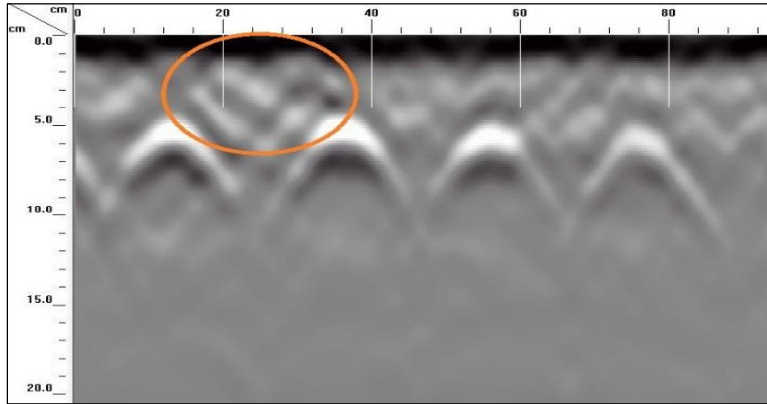
Figure 5.8. Sectional profile showing reflection of DL-2/20/B

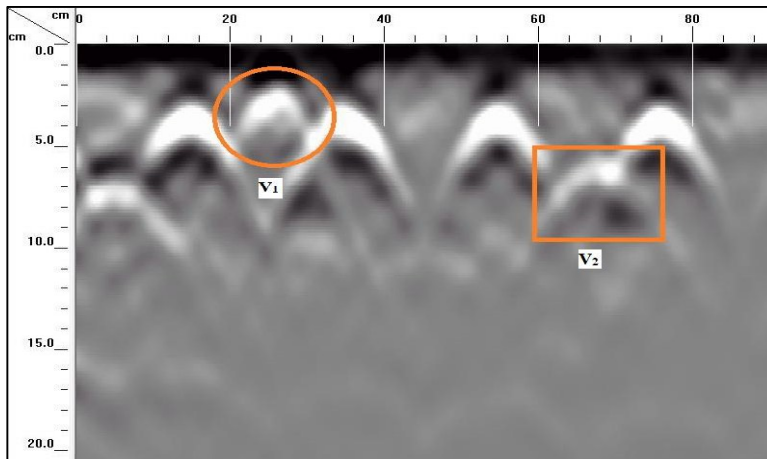
Figures 5.9 and 5.10 present the voids V_1 and V_2 in the GPR linescans.

Figure 5.9. Sectional profile showing voids V_1 and V_2

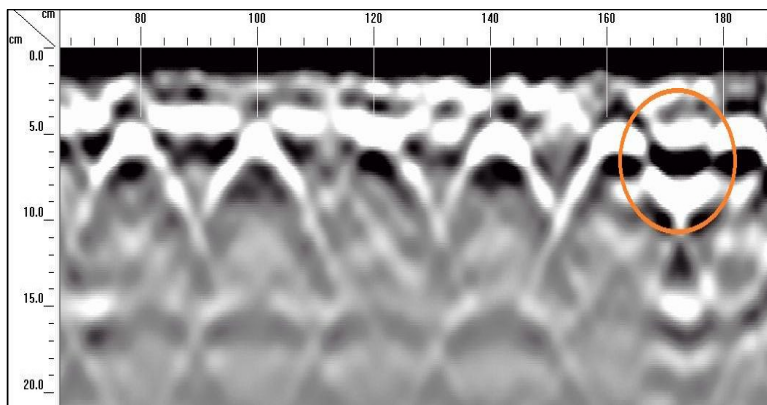
Figure 5.10. Sectional profile showing void V_1

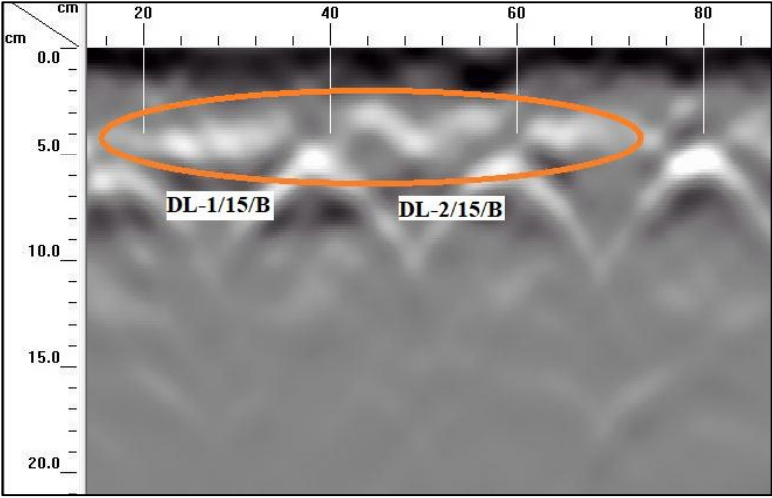
Figure 5.11 shows delaminations DL-1/15/B and DL-2/15/B, as indicated by multiple low amplitude reflections, and rebar reflection in this part appearing at a deeper level than its actual depth possibly due to the reduction in signal velocity caused by delamination.

Figure 5.11. Sectional profile indicating DL-1/15/B and DL-2/15/B

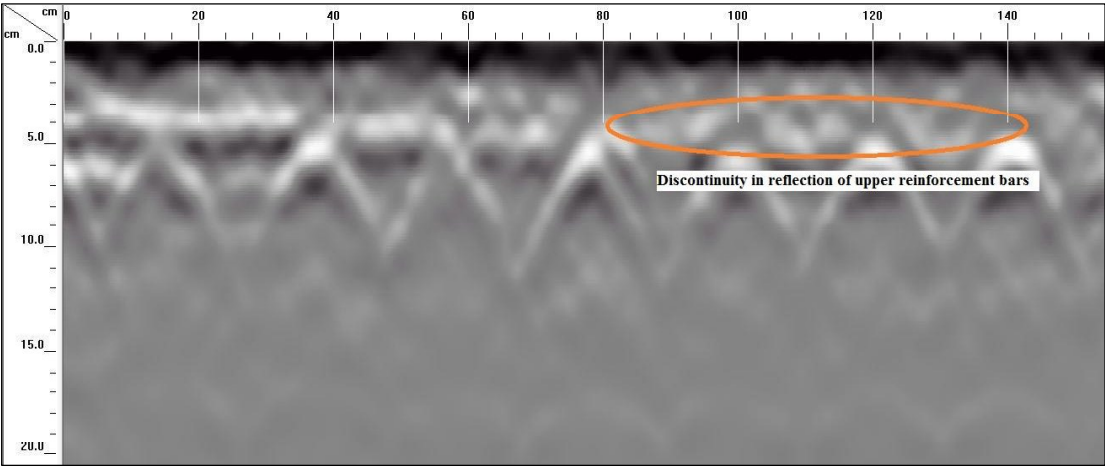
Figure 5.12 indicates DL-1/10/B, and DL-2/10/B, identified as discontinuity in reflection of upper rebars. Figure 5.13 shows the upper, and lower rebars in the sectional profile. Their transverse, and longitudinal alignment is clearly seen in the figure.

Figure 5.12. Sectional profile indicating DL-1/10/B and DL-2/10/B
