5.1 Introduction

5.2 Flexural Response of Masonry Walls Strengthened with FRP and ECC

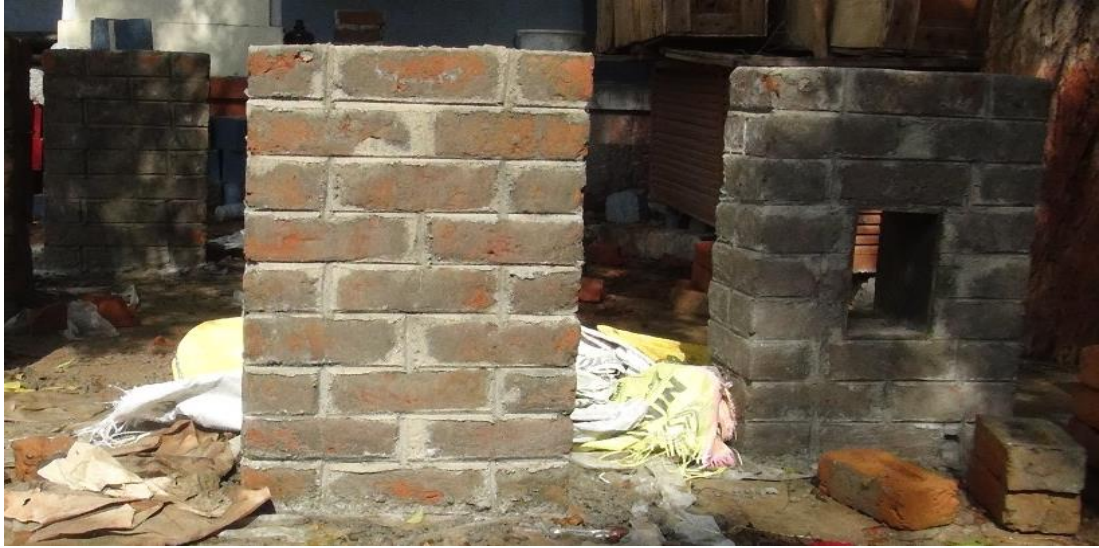
Fig. 5.1 Masonry walls

A total of twelve burnt-clay brick masonry walls (Fig. 5.1) of dimensions $762 \times 480 \times 230$ mm (height \times width \times thickness) were constructed by an experienced mason. Out of twelve, four masonry walls were constructed with the opening at the center of size $252 \times 160 \times 230$ mm (height \times width \times thickness) with the opening ratio of 11.02% (opening area/total surface area of wall).

Burnt clay bricks of C3 type were immersed in water for 24 hours before manufacturing of the walls, to avoid the absorption of water from the fresh mortars. The mortar mix ratio of 1:3 (cement: sand) (M1 type) was used to construct the masonry walls. The thickness of mortar was maintained from 10 to 12 mm. Masonry walls were cured by wet jute bag for 28 days before strengthening and testing. In order to undertake the investigations, the walls were divided into six series each made of two specimens.

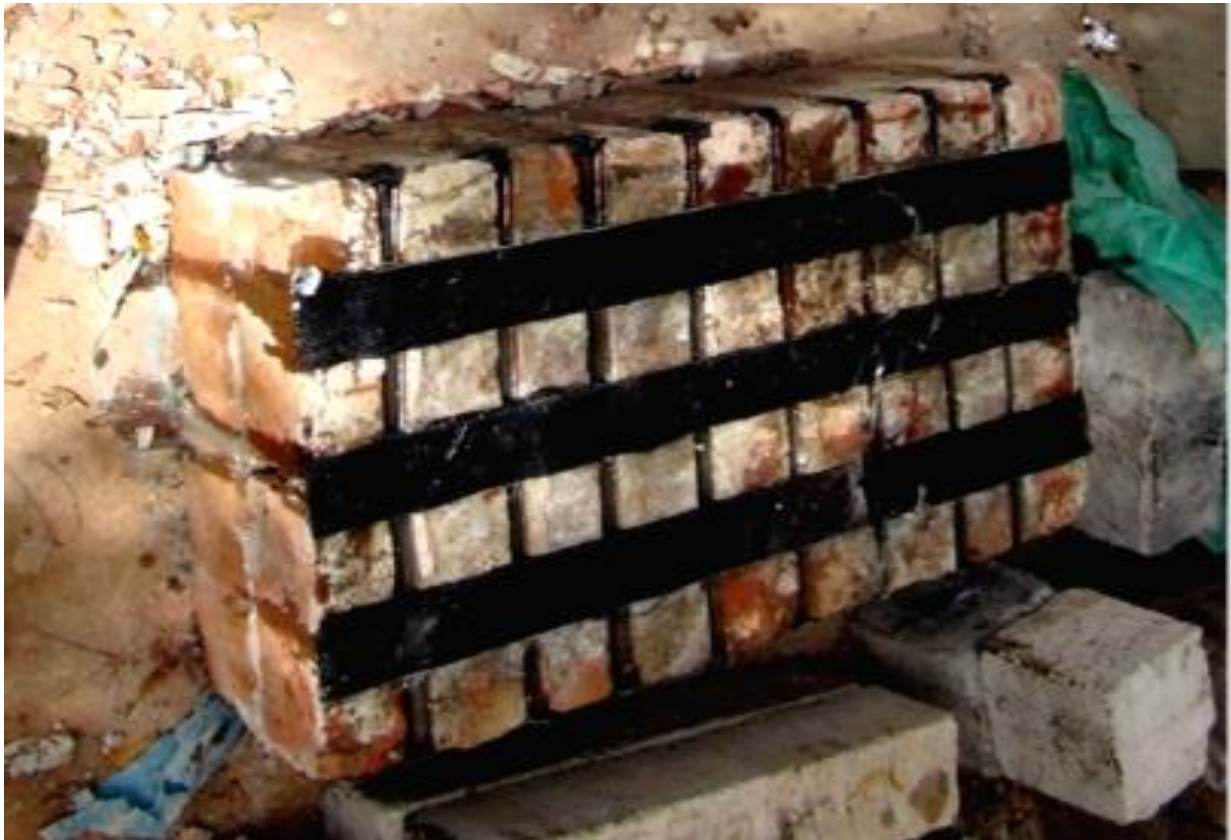
Fig. 5.5 Masonry wall with NSM CFRP bars along with CFRP strips (Series #4)

This series specimens were first strengthened in flexure like in the case of Series #3, then strengthened with CFRP strips. Epoxy was applied to the wall at the positions of the strips and spread evenly. First strip was placed on the epoxy, pressed gently and uniformly over the wall to prevent any air gaps, and then epoxy was applied and spread evenly on the first strip. This follows placing the second strip over the first one and similarly the third strip forming a three-layered thick unidirectional CFRP strips as shown in Fig. 5.5. The wall is covered and uniform pressure is applied to allow the strips to fix to the wall without formation of any air gaps. The CFRP strips strengthened walls were left for air curing for fourteen days. The walls were strengthened with 8 mm diameter CFRP bars along wall width and 2 mm thick longitudinal CFRP strips along the height of wall. The schematic diagrams of Series #4 walls are shown in Figs. 5.6-5.7.

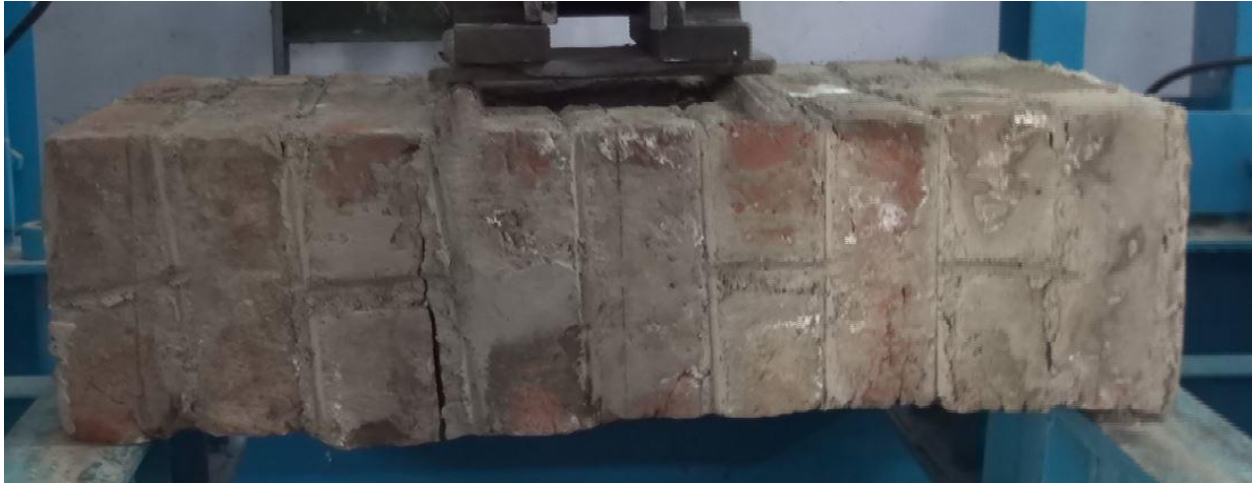
Fig. 5.13 Failure pattern of control masonry wall with opening (Series #2 specimen)

In the unstrengthened/control masonry walls with opening (Series #2), initially vertical flexural cracks started close to the left side of the loading point and propagated towards the compression face leading to sudden failure as shown in Fig. 5.13. The control masonry walls with opening (MWO) failed at ultimate average load of 10.65 kN and corresponding mid-span deflection of approximately 0.85 mm was observed. The pattern of load-deflection response of the masonry wall with opening is similar to Series #1 specimens as shown in Fig. 5.12.

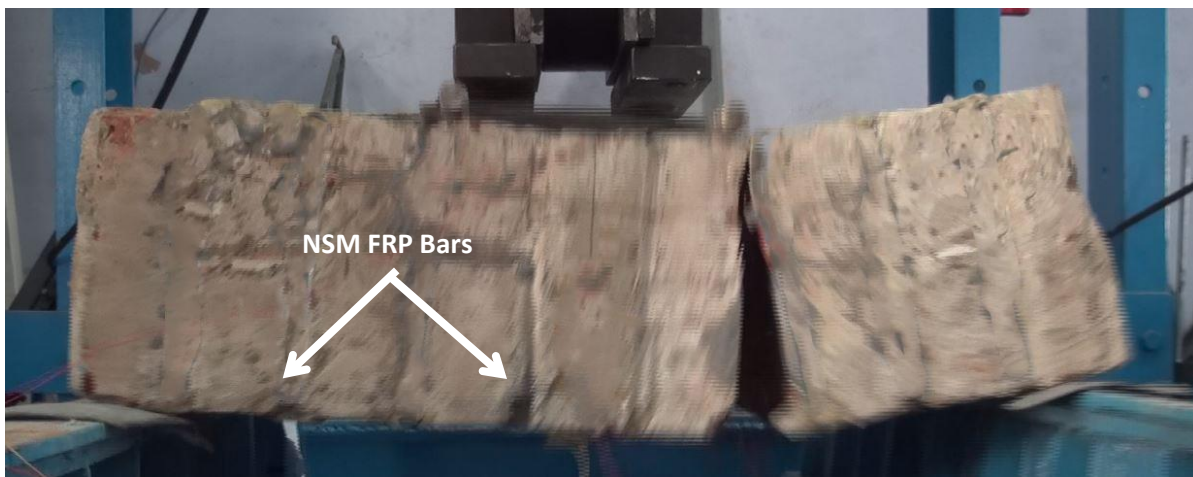
Fig. 5.14 Failure pattern of Series #3 specimen subjected to four-point loading

In the flexural strengthened masonry walls with CFRP bars along the width (Series #3), vertical flexural crack appeared close to the right side of loading point, as shown in Fig. 5.14. The normal flexural failure was observed in the Series #3 specimens. The failure pattern of the strengthened masonry walls (FMWB) is shown in Fig. 5.14. The load-deflection response of the Series #3 specimens is shown in Fig. 5.15. The response of the Series #3 specimens (FMWB) is linear up to peak load then sudden drop in load occurred. The brick-mortar bond failure was observed in the Series #3 specimens. It is observed that the NSM CFRP bars which are inserted along the width have not played considerable role for flexural strengthening. However, unexpectedly there is slight improvement in the flexural strength even with horizontal bars placed along width.

- Load carrying capacity of flexural strengthened masonry walls with CFRP bars (Series #3) has increased by 1.9 times of that of unstrengthened/ control masonry walls.

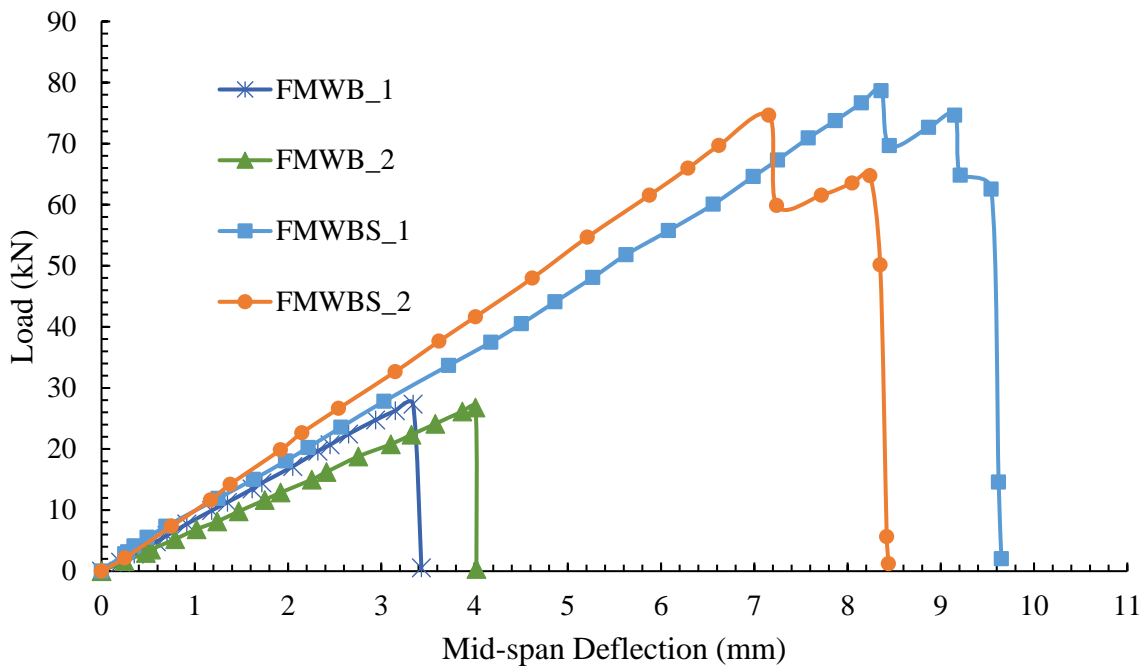
Fig. 5.15 Load-deflection response of FRP strengthened masonry walls (Series #3-4)

In Series #4 specimens (FMWBS), the shear crack developed at the mid-span of the loading which propagated towards the support. As the load increased, crack widened and failed in shear near the supports as shown in Fig. 5.16. The load-displacement response of Series #4 specimens is shown in Fig. 5.15. The response of the specimens (FMWBS) is linear up to peak load where a sudden drop in load occurred. Then, the specimen featured a gradual increase in load and deflection, possibly because of the progressive failure of CFRP strips, followed by another load decay. Finally, the rapid drop in the load response was observed. The average failure load of Series #4 specimens is observed to be 76.65 kN with corresponding average mid-span deflection of 9.04 mm. Series #4 specimens have shown better response in comparison to Series #1-3 in terms of load carrying capacity and deformation capacity.

- Flexural strengthened masonry walls with CFRP bars along with CFRP strips (Series #4) has demonstrated a drastic improvement in their load carrying capacity as well as deformation capacity.

- Load carrying capacity of flexural strengthened masonry walls with CFRP bars and strips (Series #4) has increased 5 times of that of the unstrengthened/ control masonry walls.

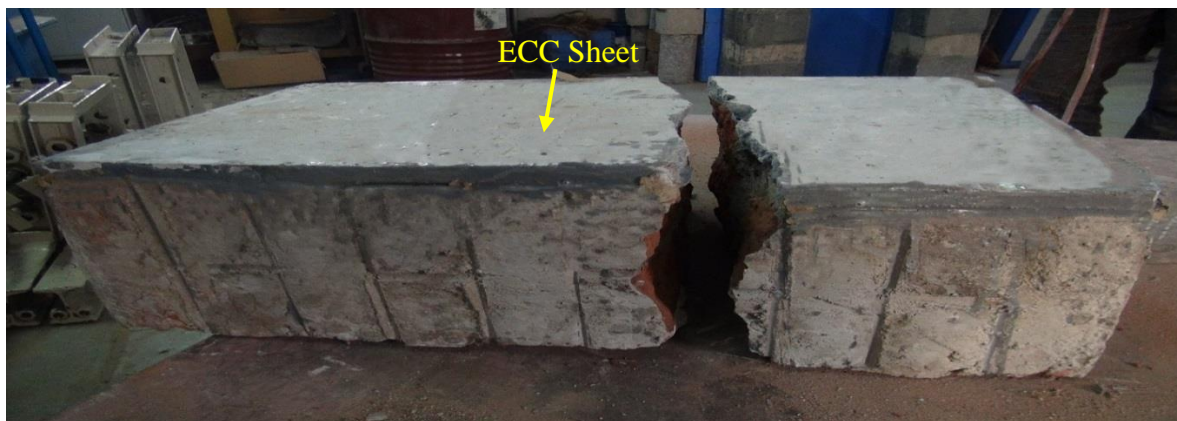
Fig. 5.17 Failure pattern of ECC strengthened masonry wall (Series #5 specimen)

In Series #5 specimens (FW), the vertical crack developed near to the left side of loading point due to stress concentration which leading to the flexural failure of the wall as shown in Fig. 5.17. The load-displacement response of Series #5 specimens is shown in Fig. 5.19. The response of Series #5 specimens is initially linear followed by a softening trend due to ductile behavior of ECC. Finally, the rapid drop in the load response was observed. The tension strengthened masonry walls with ECC sheet (FW) failed at unultimate average load of 83.80 kN which is almost 5 times of that of control masonry wall (MW).

- Load carrying capacity of flexural strengthened masonry walls with precast ECC sheet (Series #5) is found to be about 5.4 times of that of control/unstrengthened masonry walls.
