Development of in-situ asphalt pavement and concrete bridge deck testing facility for controlled field investigations

3.1. Introduction

3.3. Development of in-situ asphalt pavement test section

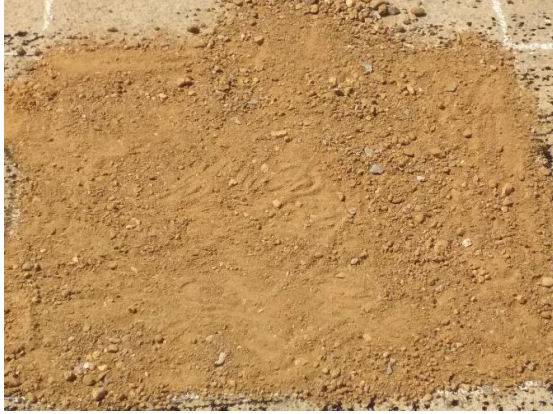
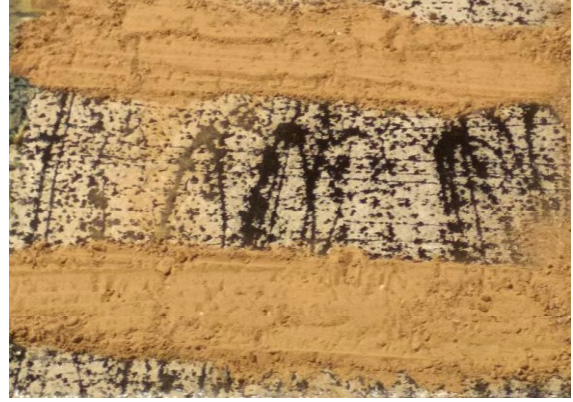
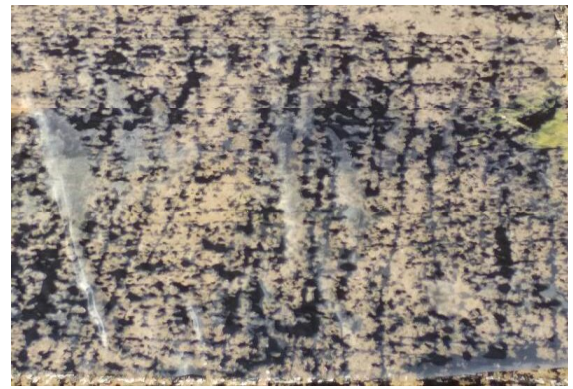
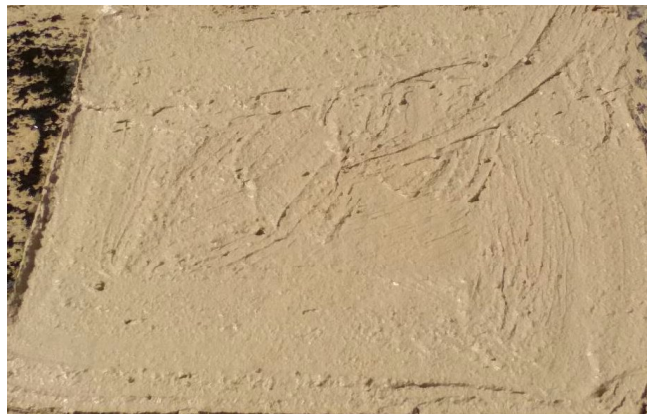
Figure 3.5. Different bonding conditions introduced to various blocks of in-situ asphalt pavement test section

Step 3: Materials to achieve S-3, DW-3, G-3, PO-3 and B-3 bonding conditions were introduced suitably at their locations (along row-3). Three PVC pipes (P-1a, P-1b, P-1c) were buried, beneath the existing pavement surface at the cored locations (refer Figure 3.2, 3.5 and 3.6).

(a) Sand (S)

(b) Dust along wheel path (DW)

(c) Grease (G)

(d) Polythene (PO)

(e) Bentonite slurry (B)

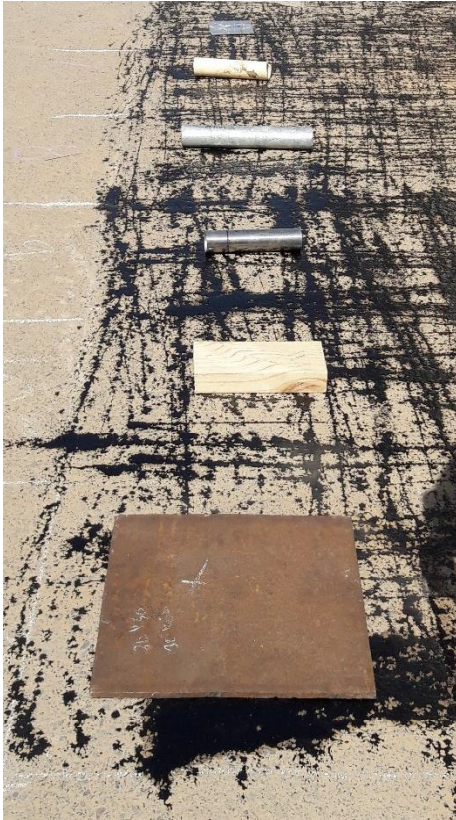
Figure 3.7. Different anomaly conditions introduced to various blocks of in-situ asphalt pavement test section

Step 4: Different anomaly conditions were introduced at the corresponding blocks (A-3, P-3, CI-3, SP-3, W-3, C) as shown in Figure 3.7. Guide marks using paint were used to know the precise location of the anomalies.

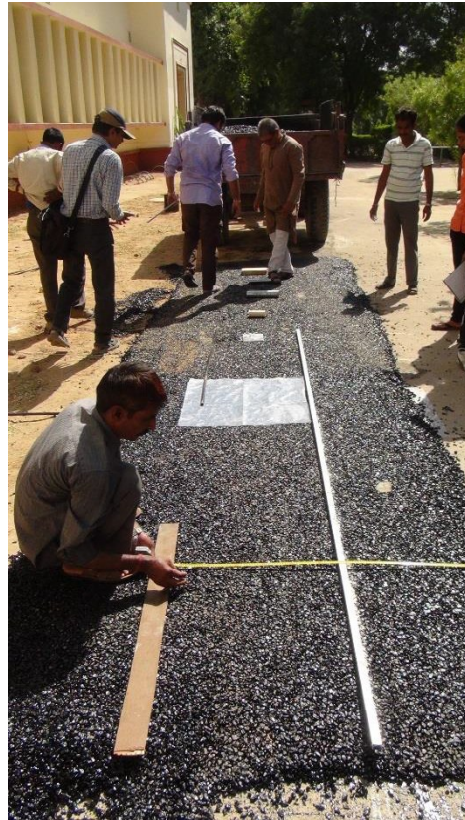
Figure 3.8. Placement of different bonding and anomaly conditions along row-2

Step 7: After the first lift was cooled down, the tack coat was applied and the various bonding and anomaly conditions were introduced along row-2 (refer Figure 3.8).

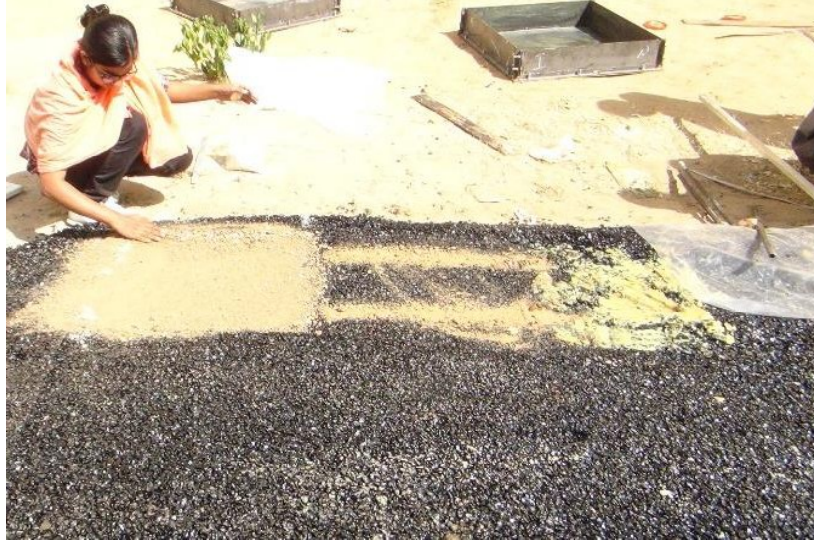
Figure 3.9. Placement of different bonding and anomaly conditions along row-1

Step 10: The final HMA lift was laid after the cooling down of second layer (refer Figure 3.9), and compaction was done using smooth wheel roller (refer Figure 3.10).

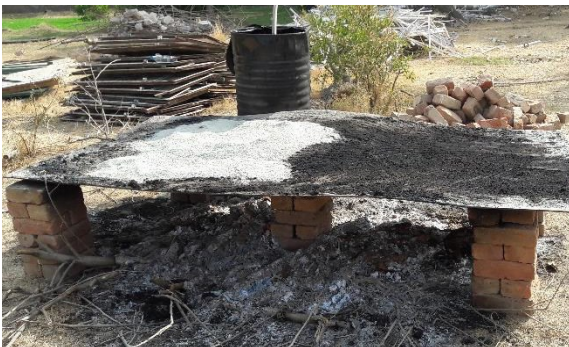
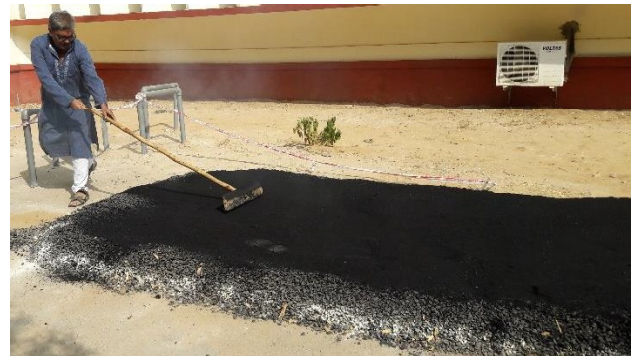
Figure 3.11. Preparation and application of seal coat

Step 11: The desired 150 mm thick section was constructed and the total thickness of the overlay remained same for the entire test section. Seal coat was then applied on the top as shown in Figure 3.11. Figure 3.12 shows various stages of construction of the test section.

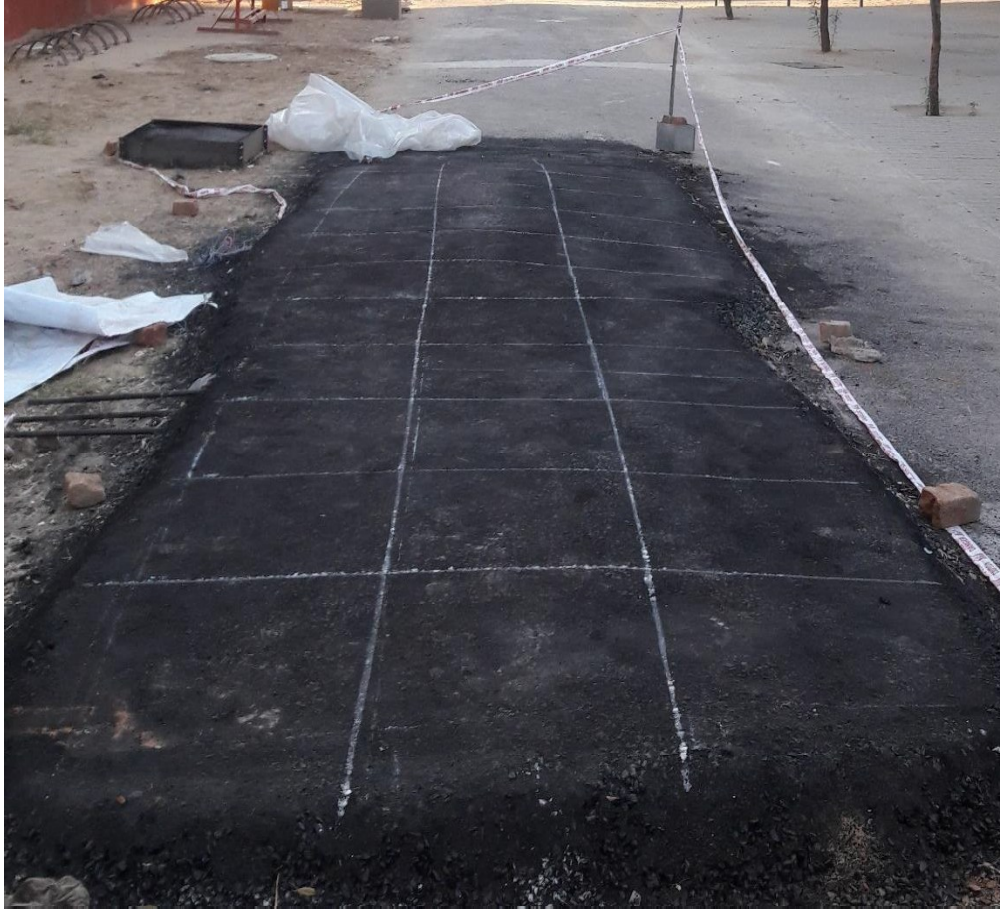
Figure 3.13. Constructed in-situ asphalt pavement test section

Step 12: Finally, the top surface was marked with paint for the locations of bonding and anomaly conditions with the help of guide marks (refer Figure 3.13). Figures 3.3 to 3.13 shows the actual pictures of construction of in-situ asphalt pavement test section.

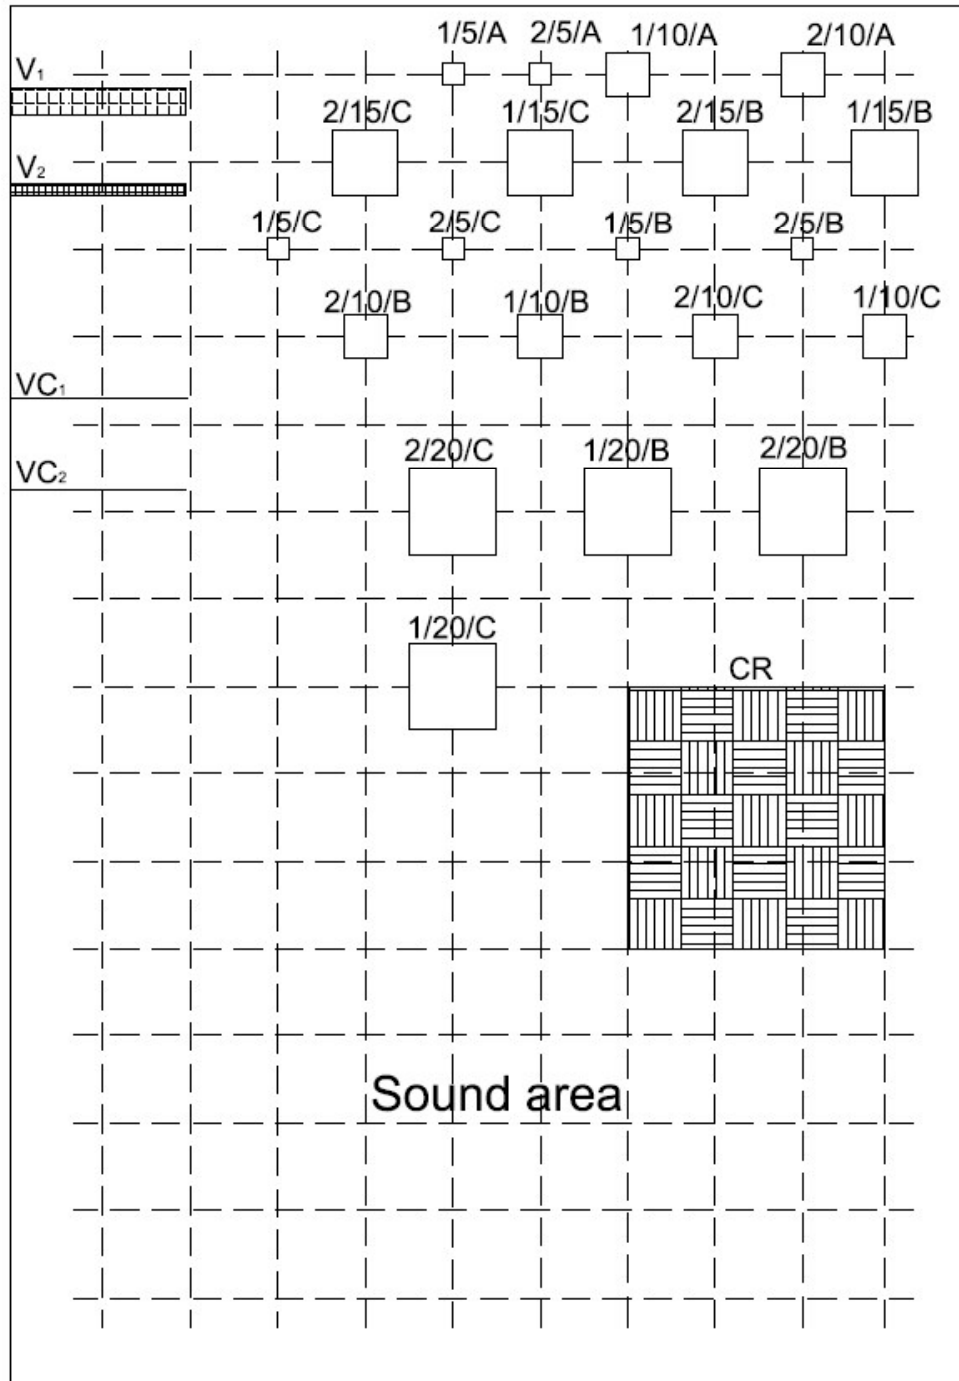
Figure 3.15. Design of concrete bridge deck slab at BITS Pilani – Pilani campus and defect distribution

A concrete bridge deck slab of lateral dimensions 300 cm × 200 cm and 20 cm thickness was fabricated and supported on brick walls. The slab was built with two mats of reinforcement consisting of 12 mm diameter steel bars spaced 200 mm center-to-center in both longitudinal and transverse direction. The top and bottom concrete cover of 40 mm was provided. Since the analysis for traffic loading and unloading is not the part of this study, therefore the provision of reinforcement was considered on the basis of minimum reinforcement criteria with two mats provided, as per IRC specifications (IRC 112, 2011). The slab was simulated with twenty delaminations, a corroded reinforcement mat, two voids, and two vertical cracks. The dimensions for each of these simulated defects are chosen similar to the most commonly occurring in field. One-third area of the slab (200 cm × 100 cm) was kept free from any defect in order to compare the conditions of sound and defected area. All the defects were placed at their pre-defined location before laying the concrete. The concrete mix was prepared on site and placed. The approximate defect distribution is depicted in Figure 3.15. Table 3.2 summarizes the details of these defects.

Type of defect	Code	Size (cm)	Thickness (mm)	Diameter (mm)	Depth from surface (mm)
Void	V ₁	40	-	60	20
	V ₂	40	-	25	80
Vertical crack	VC ₁	40	1	-	20
	VC ₂	40	2	-	60
Corrosion	CR	60 × 60	-	-	40
Delamination	DL-1/5/A	5 × 5	1	-	25
	DL-2/5/A	5 × 5	2	-	25
	DL-1/10/A	10 × 10	1	-	25
	DL-2/10/A	10 × 10	2	-	25
	DL-1/15/B	15 × 15	1	-	40
	DL-2/15/B	15 × 15	2	-	40
	DL-1/15/C	15 × 15	1	-	136
	DL-2/15/C	15 × 15	2	-	136
	DL-1/5/C	5 × 5	1	-	136
	DL-2/5/C	5 × 5	2	-	136
	DL-1/5/B	5 × 5	1	-	40
	DL-2/5/B	5 × 5	2	-	40
	DL-1/10/B	10 × 10	1	-	40
	DL-2/10/B	10 × 10	2	-	40
	DL-1/10/C	10 × 10	1	-	136
	DL-2/10/C	10 × 10	2	-	136
	DL-1/20/B	20 × 20	1	-	40
	DL-2/20/B	20 × 20	2	-	40
	DL-1/20/C	20 × 20	1	-	136
	DL-2/20/C	20 × 20	2	-	136

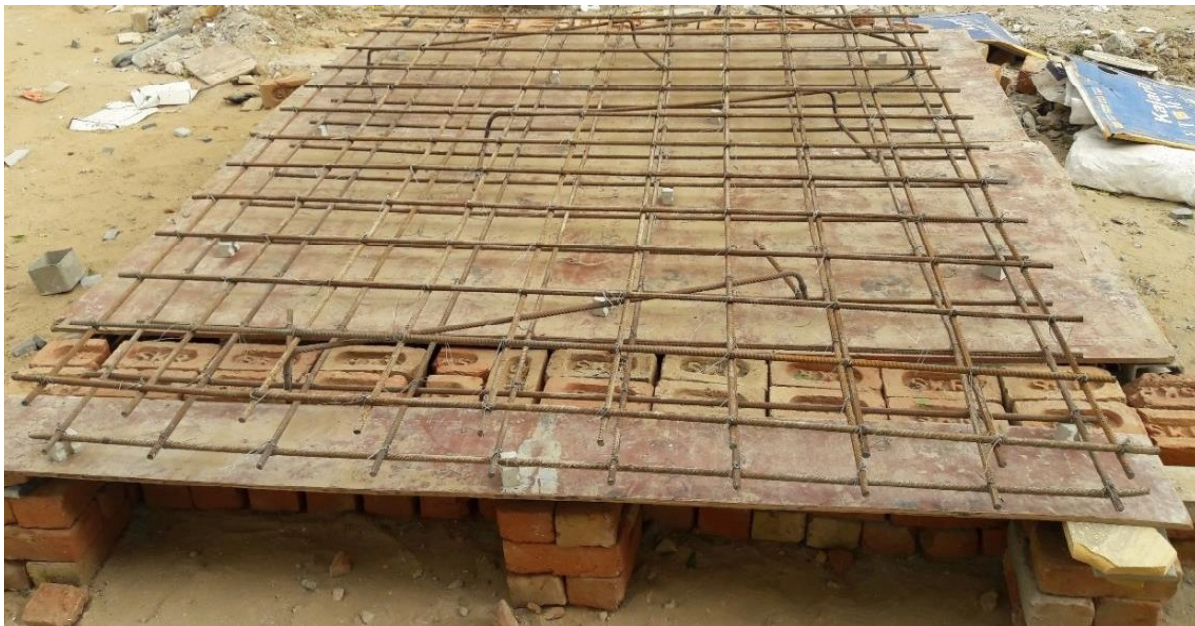
Figure 3.16. Reinforcement mats laid for the construction of concrete bridge deck slab

Step 2: The shuttering was placed in the required dimensions and mats of reinforcement were laid with 40 mm cover (refer Figure 3.16).

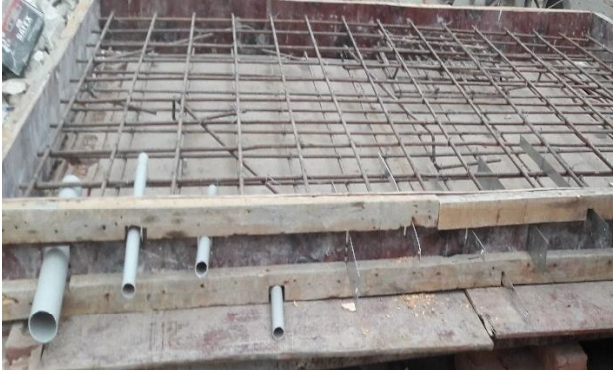
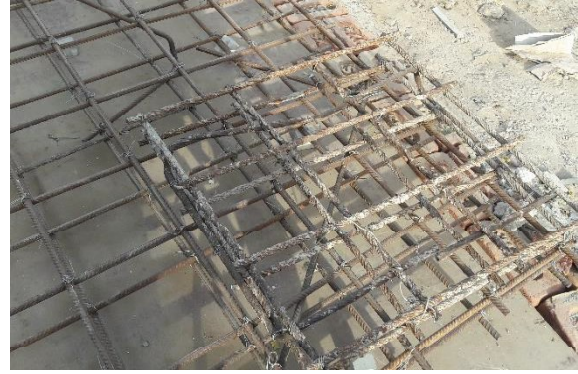
Figure 3.17. Shuttering with induced defects before casting slab

Step 3: Mat of corroded rebars was prepared and fixed suitably with the normal reinforcement at one end of the fabricated deck. PVC pipes and steel strips were greased to ensure their easy removal and were fixed at the desired location before laying concrete, as shown in Figure 3.17.

(a) PVC pipes and steel strips

(b) Mat of corroded rebars

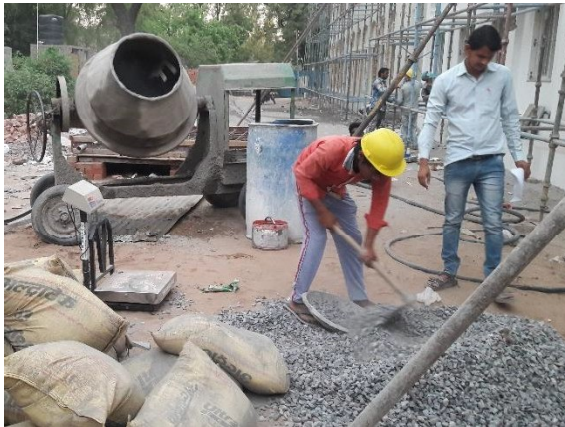
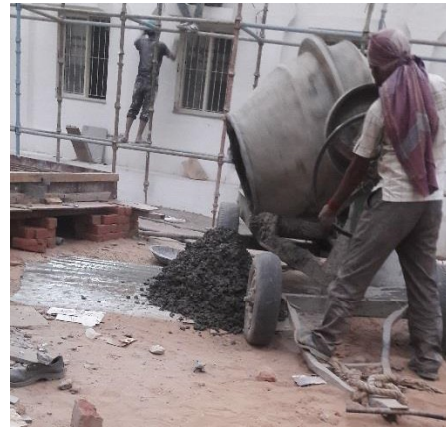
Figure 3.18. On-site preparation of concrete mix in tilting drum type concrete mixer

Step 4: Concrete mix of required grade was prepared on site in tilting drum type concrete mixer (refer Figure 3.18).

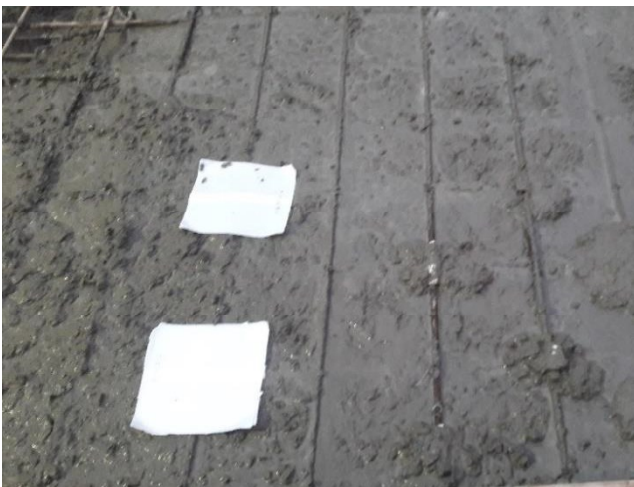
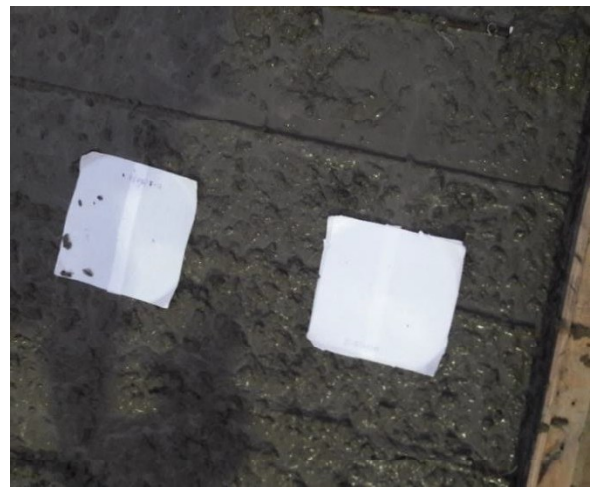
Figure 3.19. Placing of foams to induce delaminations while concreting

Step 6: Concrete was again poured till the level of top reinforcement mat (approximately 40 mm deep from surface) and the delaminations at this level were introduced, as shown in Figure 3.19.

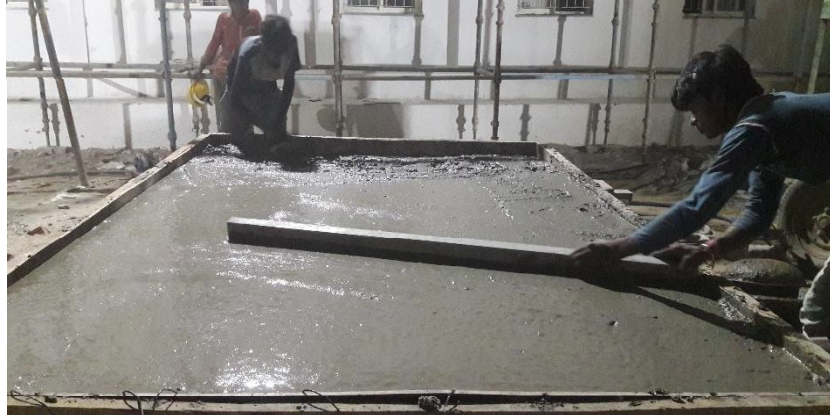
Figure 3.20. Final finishing while casting slab

Step 7: Another set of delaminations to be located at the depth of 25 mm from the surface were introduced by foam pieces, and the concrete was poured to cover the entire area of the slab. Final finish was given to the slab as shown in Figure 3.20 and the slab casting was completed (refer Figure 3.21).
