Controlled field evaluation on asphalt pavement test section using NDT techniques

4.1. Introduction

4.2. Evaluation of asphalt pavement test section using IRT method

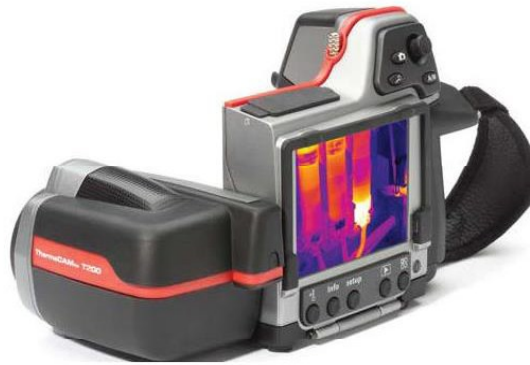
Figure 4.2. FLIR T250 thermal camera

The instrument utilized for taking thermal images in this study is a FLIR T250 infrared camera (refer Figure 4.2). It consists of microbolometer as a detector whose electrical resistance is changed when infrared radiations encounter and heats it. This change of electrical resistance is measured

and converted into a range of temperatures to produce an image. Laser pointer of the camera helps to aim the target surface, and the camera collects and stores images of 320×240 pixels resolution. The resolution of the digital images, which were captured along with thermal images was 2048×1536 pixels.

Table 4.1 summarizes some of the main technical specifications of the thermal camera (FLIR T250, 2009). It is expected that the thermal cameras with higher pixel resolution would fetch better quality thermograms and should be preferred for field applications particularly when the camera is to be mounted over a moving vehicle to take the images. Due to the unavailability of better resolution camera, this study is performed with 320×240 pixels resolution camera and the images of the area under study are taken closely.

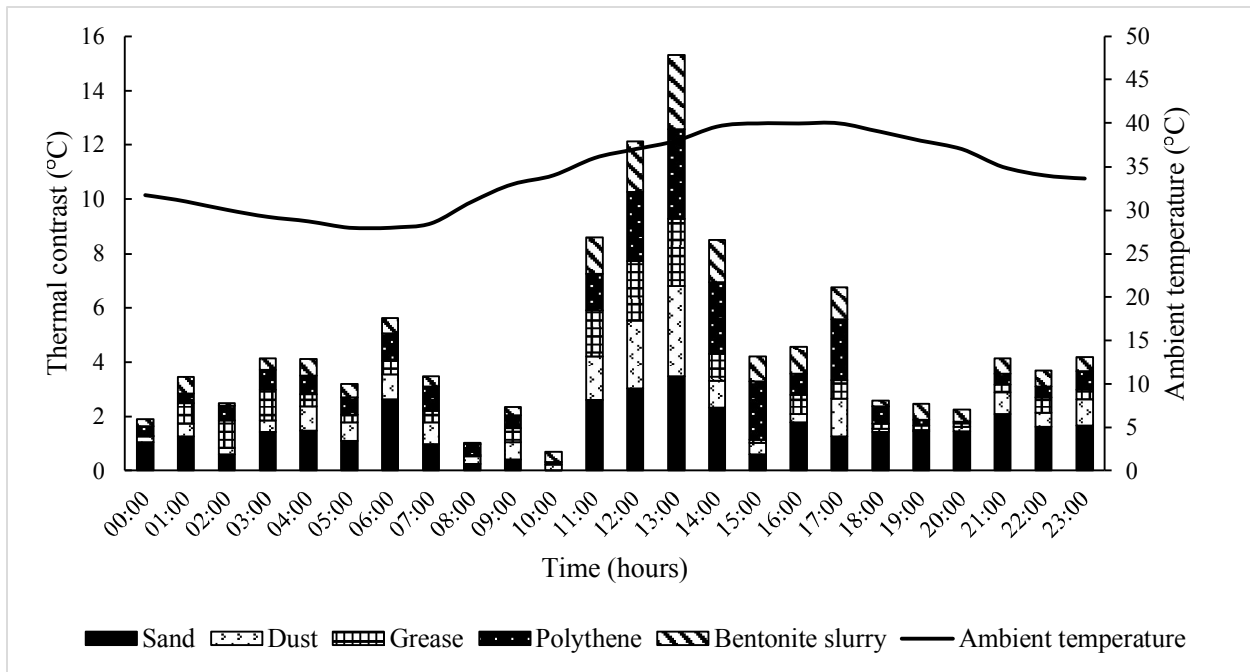
Figure 4.4. Hourly thermal contrast variation due to different interlayer bond conditions in the test section

Figure 4.4 presents the variation of thermal contrast for each of the debonded blocks, over a period of 24 hours. The thermal contrast can be seen to be strongly influenced by the change in ambient temperature. It is found to be increasing with an increase in ambient temperature.

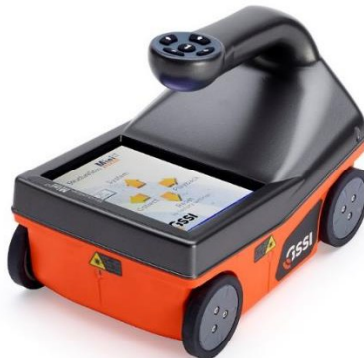
Figure 4.15. StructureScan Mini

To investigate the ability of GPR to detect asphalt pavement debonding and underground anomaly, the experimental study was carried out on the in-situ asphalt pavement test section. The test section, as explained in Chapter 3, consists of artificially created bonding conditions and anomalies. The 150 mm thick pavement section was radiated by StructureScan Mini containing 1.6 GHz antennae provided by GSSI and shown in Figure 4.15. The instrument was procured with the help of Aimil Ltd., New Delhi.

The 1.6 GHz antenna represent high-resolution, shallow penetration and ground-coupled antenna type. The best performance is achieved by keeping the antenna within 1/10 of the wavelength from the surface and large air gap must be avoided to prevent reflection of radar energy in the air. The radar energy moves perpendicular to the surface of the test medium. The transmitter-receiver offset

in the 1.6 GHz antenna is 58 mm. This indicates that the targets in the top 58 mm may appear fuzzy in raw data which are then corrected using the Background Removal technique.

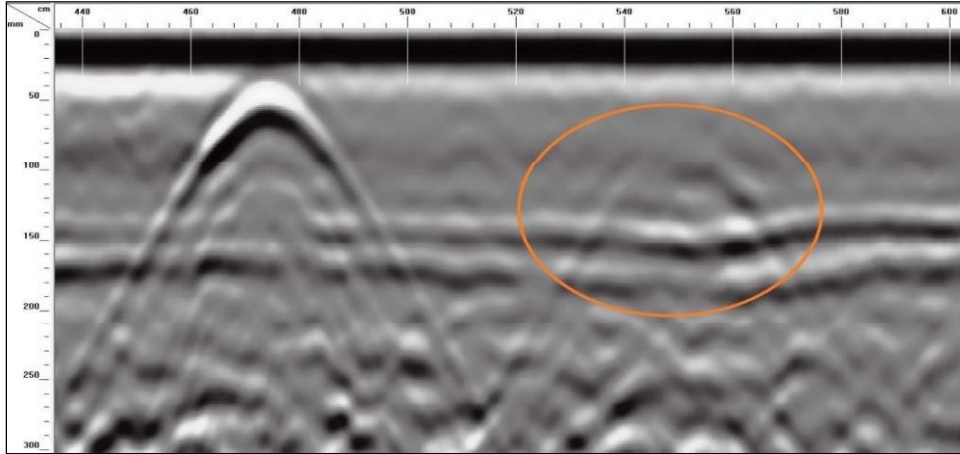
Figure 4.22. Sectional profile showing reflection of W-2

Figure 4.22 shows the reflection of the wood block (encircled). It can be easily noticed that the reflection of wood is dimmer than the reflection from metals. Also, since the thickness of wood block is less than the diameter of nearby steel pipe, the peak of its reflection appears deeper as compared to the reflection peak of steel pipe in the profile.

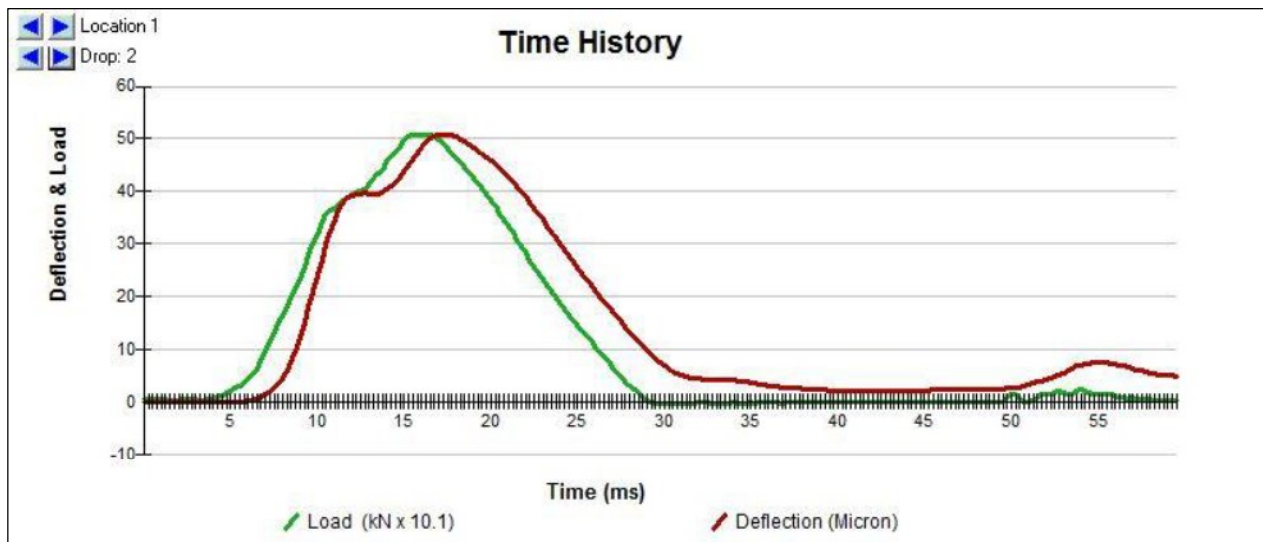
Figure 4.30. Time-history plot of LWD data

The drop weights used for LWD testing on the asphalt pavement test section were 10 kg, 15 kg and 20 kg. Three geophones (D1, D2 and D3) were used in this study with configuration as 0 (D1), 300 mm (D2) and 600 mm (D3) from the center of load cell. Loading plate of 150 mm diameter was used. Not much information was provided by D3 geophone and the deflections measured by it were close to zero. Three rounds of testing, each for three drop weights were conducted on different debonded and bonded blocks to compare the measured deflections of a fully bonded area to a debonded area. Theoretically, a debonded section should have higher deflection than a section that is fully bonded. However, the fully bonded block provided similar deflection measurements to those blocks with debonding. The probable reason could be low magnitude of load used in LWD (maximum 20 kg), which would be insufficient to produce deflection in pavements. On the basis of these results, the use of LWD was found to be insignificant and it was not used further in this study. Figure 4.30 presents a typical time-history plot of applied load and measured deflection (geophone D1) obtained during LWD testing of the test section.
