Uncontrolled field evaluation using NDT techniques

6.1. Introduction

6.2. Study area

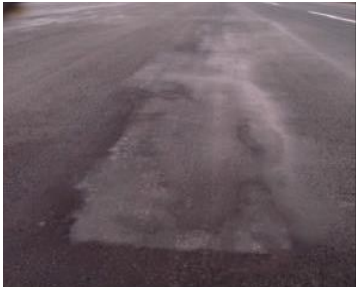
(a) Patching on runway

The existing runway surface was found to be in the variable state as seen from the results of the visual survey. An area around 35 m × 20 m between 0.025 km and 0.060 km covering almost 35% of the turn pad, showed depressions and deformations, caused particularly by shearing action of aircraft turning movements. Area from 0.05 km to 1.80 km was in fair condition with few corrugations and block cracks. The runway around exit taxiway ET4 intersection (1.80 km to 2.00 km) seemed to be in fair condition with patching and depressions at some places. Fatigue cracks have been observed to predominate area from 2.25 km to 2.50 km. Raveling and material loss have also been observed at the cracked areas. The touch-down zone (2.60 km to 2.90 km) from runway direction '02' was recognized to be severely distressed and damaged. This area has been exposed to a majority of landings by heavy commercial airlines, which impart their effect on pavement condition. At 2.87 km, the distress severity has been found to decrease. Heavy rubber deposition was found which made the surface glossy and reduced skid resistance.

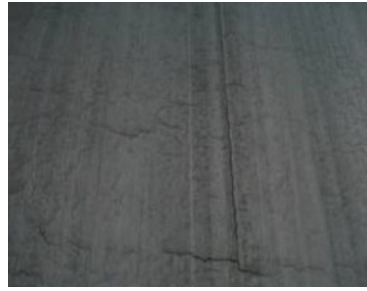
(b) Cracks on runway

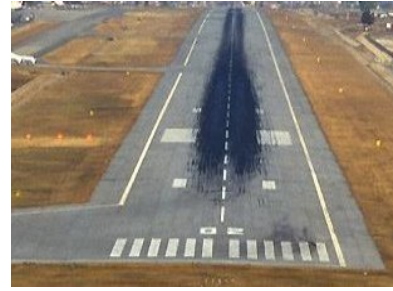
(c) Rubber deposition on runway

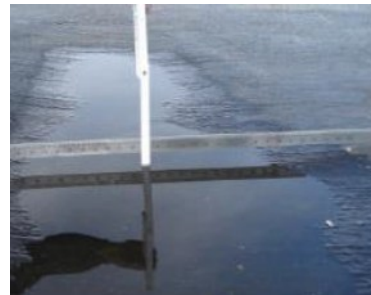
(b) Rutting on exit taxiway ET2

The pavement surface was observed to be in fair condition except for localized distress like narrow interconnected alligator cracks and raveling.

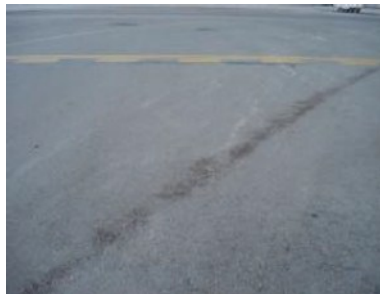
(c) Raveling on exit taxiway ET3

Due to its central location with the international apron, it is mostly used for taxing large aircraft. This taxiway was found to be relatively more distressed and depressions, cracks and raveling were observed.

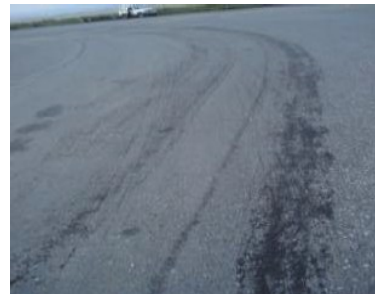
(d) Bleeding on exit taxiway ET5

This taxiway was observed to be in poor condition. A joint reflection crack prevailed along shoulder widening. The surface was generally marked by narrow interconnected alligator cracks, depression and bleeding. Figure 6.3 shows actual images of distresses present on parallel, and exit taxiways observed during the visual inspection.

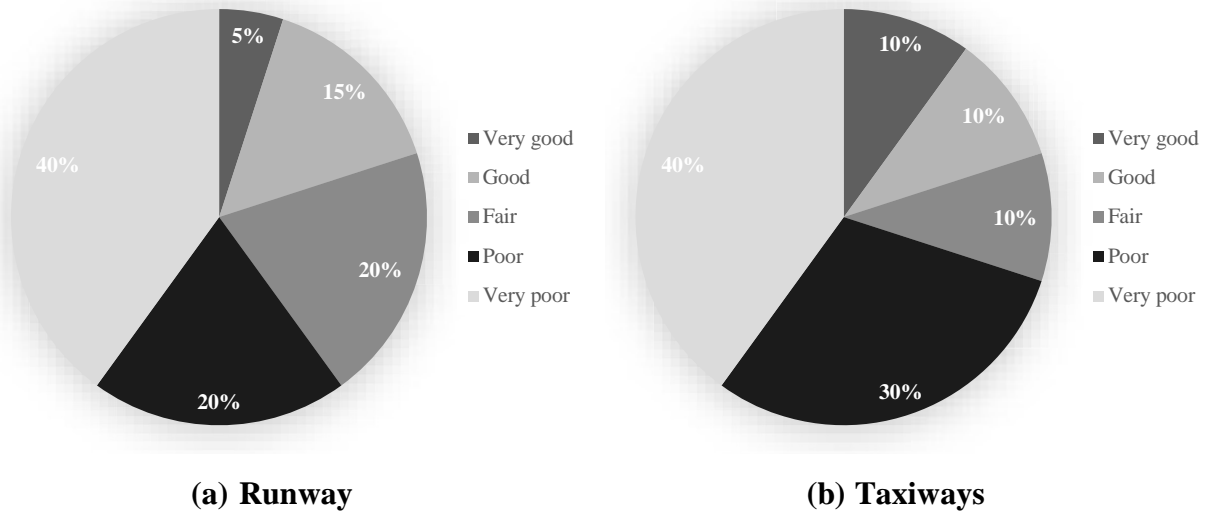
Figure 6.4 presents the area-wise distribution of pavement surface condition of runway and taxiways, respectively, based on the results of visual inspections. It can be seen that 40% area of the runway was in very poor condition, and 20% area was in poor condition. The area in fair condition is 20% of the total area that would eventually advance to the poor condition due to its continual deterioration if left unattended. Remaining 15% and 5% of the area were rated as good and very good, respectively. In the case of taxiways, 40% of the area was in very poor condition and 30% was in poor condition, which showed that 70% of the area was already deteriorated. Around 10% of the surface was rated as fair, another 10% as good, and the remaining 10% as very good.

Figure 6.4. Area-wise distribution of pavement surface condition rating

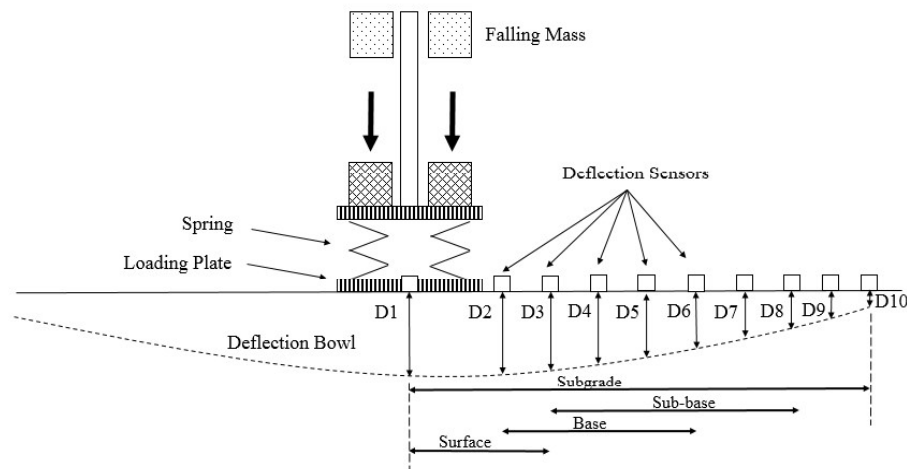
Figure 6.5 depicts the working principle of HWD. The falling mass overloading plate temporarily deforms the pavement into a deflection bowl, whose deflections (D1 to D10) are measured at various radially outward points from the centre of loading plate. These sensors provide structural condition information of various pavement layers depending on their position with respect to the centre, as illustrated in the figure.

Figure 6.5. The working principle of HWD

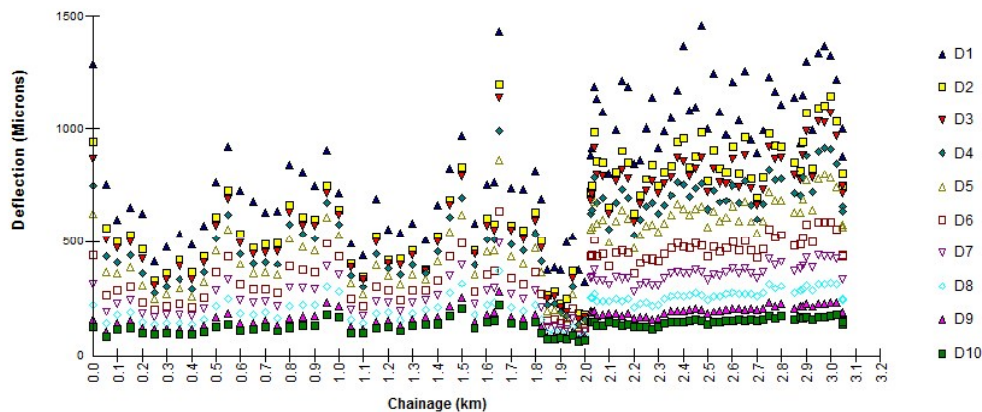
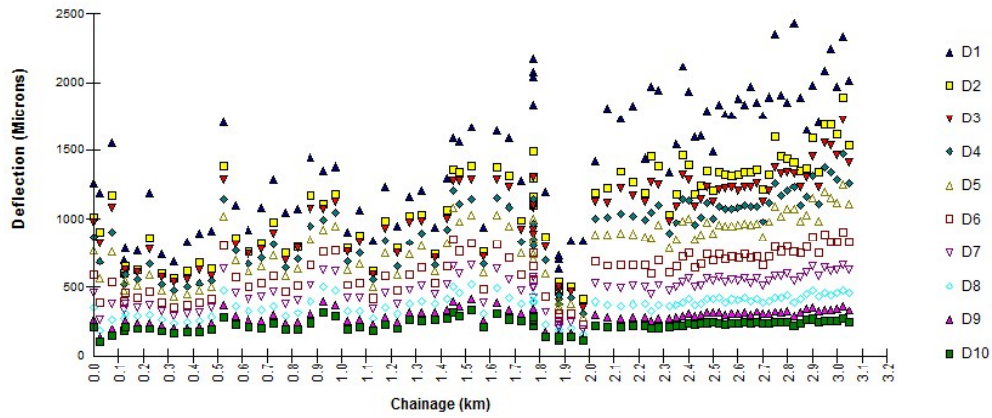
Deflections of pavement surface represent their most probable structural condition. Higher pavement surface deflections indicate weaker pavement strength. The falling mass of HWD deforms the pavement into a deflection bowl in which central deflection is the highest. The variation of deflections measured by ten sensors of HWD (D1 to D10, refer Figure 6.5) along L3, L6, R3, and R6 (where L and R refers to left and right side of runway centerline; 3 and 6 represents 3 m and 6 m offset, respectively) are presented in Figure 6.6. The non-uniform variation of deflection shows varying strength of pavement structure. Higher deflection values are typically obtained at zones of 0.40 to 0.60 km, and 2.00 to 3.05 km, measured from '02' end of the runway. This gives an indication that these are weak zones, which has also been concluded from the results of the visual survey.

Figure 6.6. Variation of pavement surface deflections along the runway

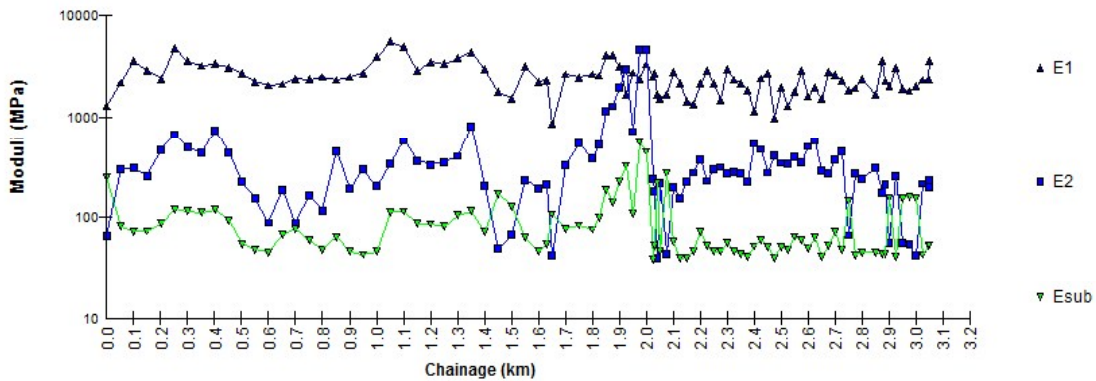
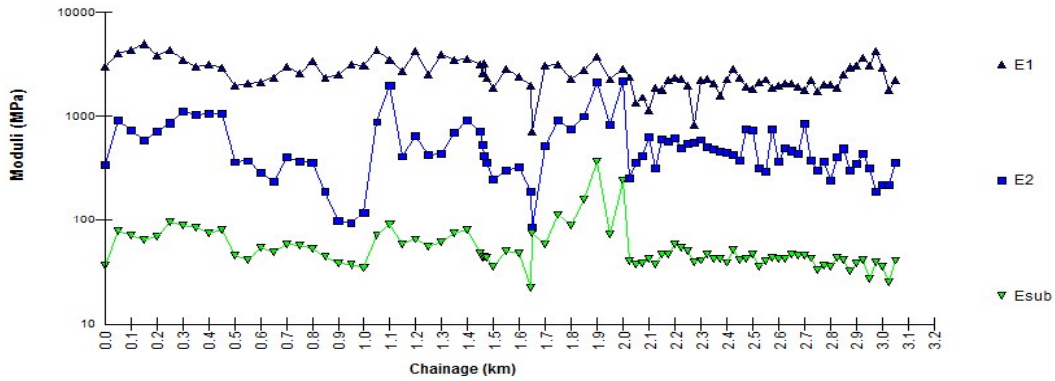
The modulus value of any structure is a measure of its stiffness. The higher values of modulus indicate that the material is stiffer and less likely susceptible to deformation under load. Therefore, it is crucial to consider the moduli value of pavement layers for assessing their current state. The back-calculation of all the deflection values, with suitable input seed moduli and using GPR data to input the layer thickness values, resulted in estimating the moduli of subgrade, base, and asphalt concrete layers. The longitudinal variation in moduli along the runway has been presented in Figure 6.7, which clearly demonstrates that higher moduli values indicate high strength of pavement layers at the locations with the lower deflections and vice versa. The zone 2.00 to 3.05 km can be observed to have either inconsistent or low moduli values. The results are found to be consistent with visual surveys, and other test results at these locations.

Figure 6.7. Variation of pavement layer moduli along the runway

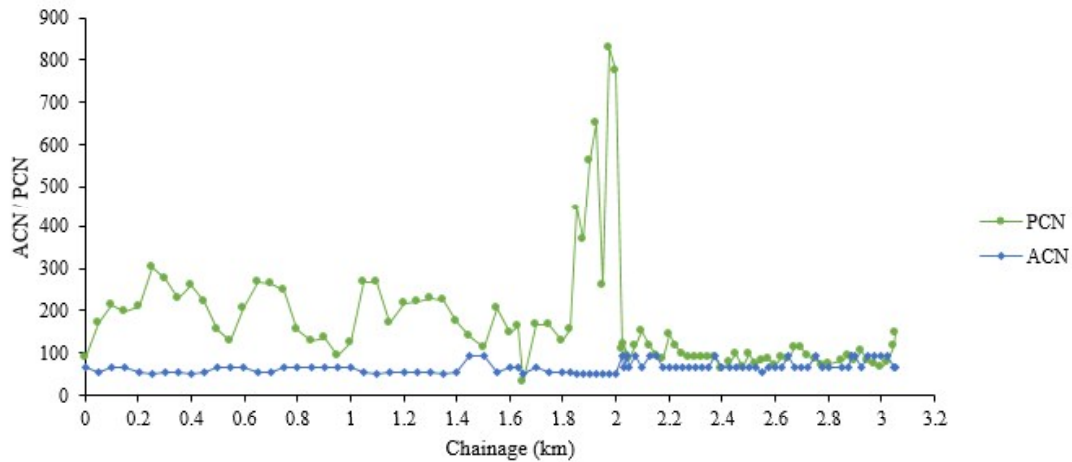
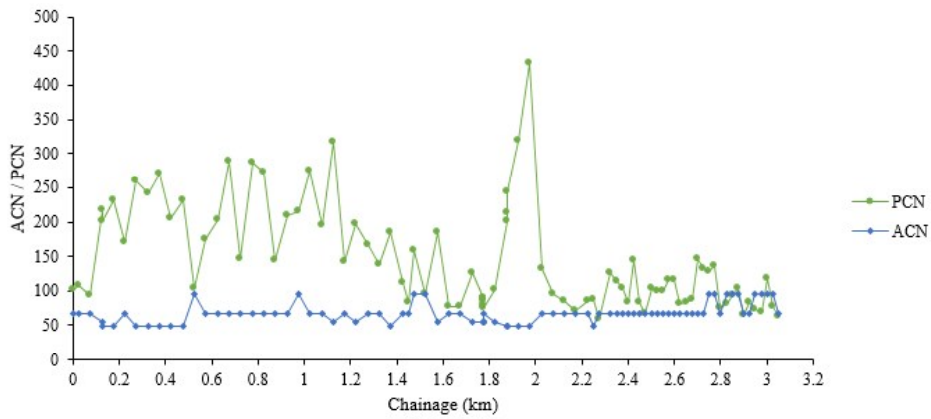
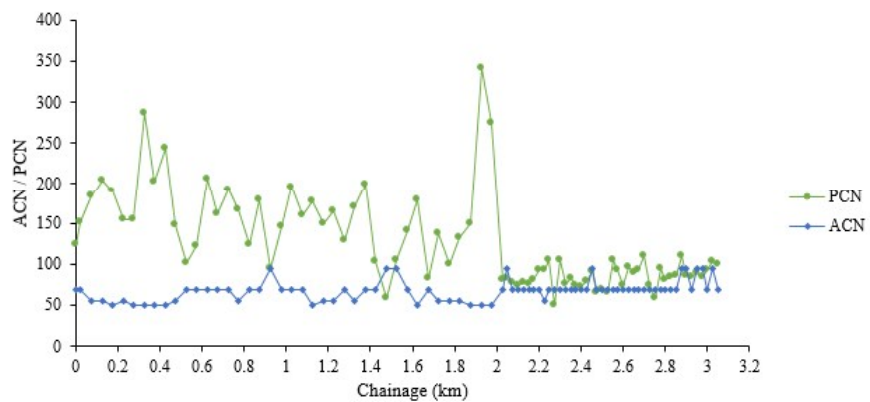
Figure 6.8 shows the plots of ACN and PCN numerical value. The critical aircraft considered here was Boeing B777-200. It can be seen that at the locations where moduli values are lower, PCN numerical values are also less. From chainage 2.00 km to 3.05 km, it can be concluded that since this section was already in poor condition, as seen from deflection and moduli values, the PCN values over the entire section are lower as compared to other sections.

Figure 6.8. Variation of ACN and PCN value along the runway

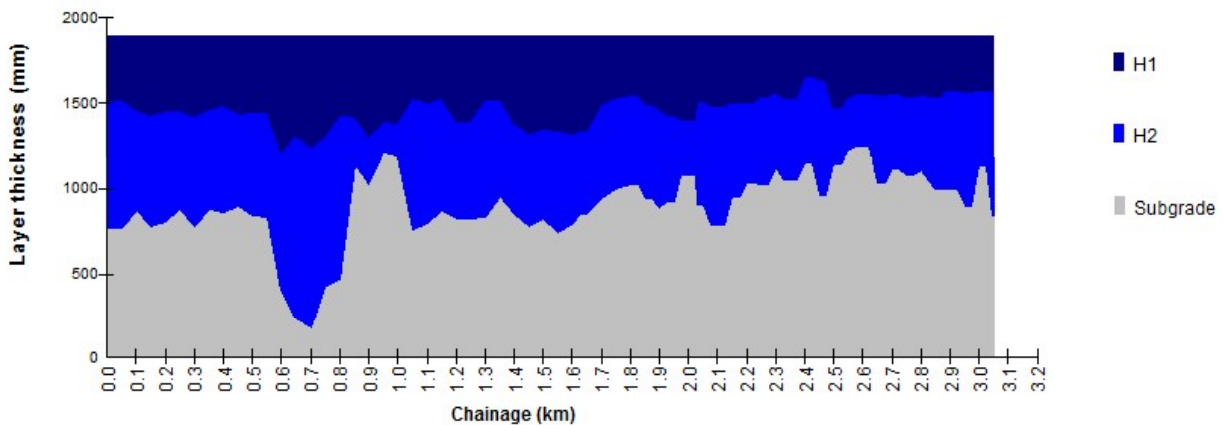
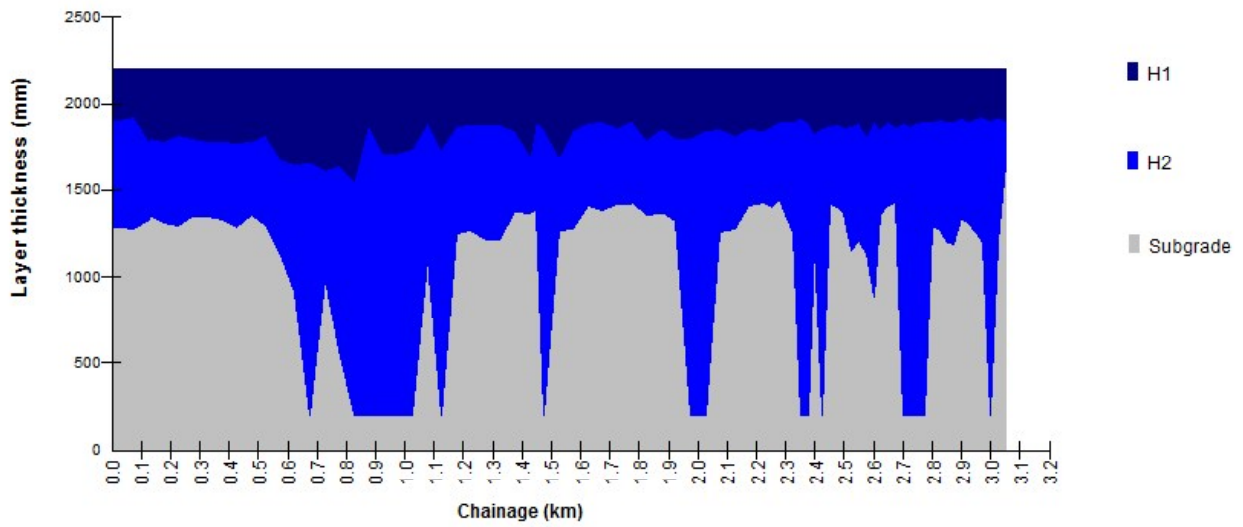
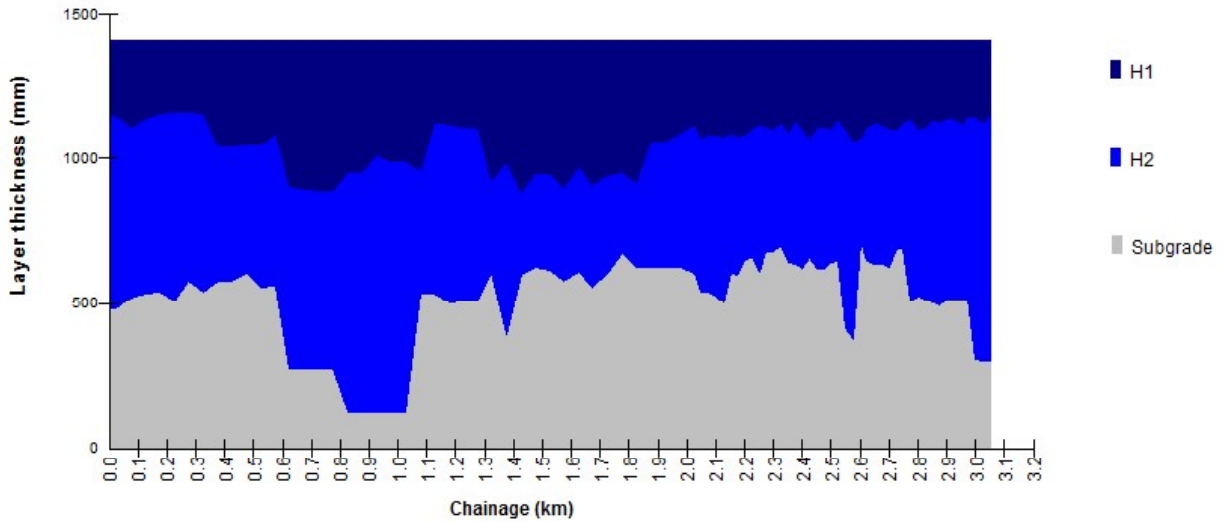
GPR with 400 MHz and 1500 MHz antennae has been used to measure the thickness of pavement layers in this study. The survey has been conducted along six profiles parallel to the centerline of runway and at 3 m, 6 m and 9 m offset both sides. Figure 6.9 presents the longitudinal profile of runway pavement layer thicknesses (asphalt concrete layer: H1, base: H2, and subgrade), chainage-wise, along L3, L6, R3, and R6 (where L and R refers to left and right side of runway centerline; 3 and 6 represents 3 m and 6 m offset, respectively). The thickness of the first layer (H1) as measured from GPR, varies from 234 mm to 689 mm, and that of the second layer (H2) varies from as low as 181 mm to as high as 1717 mm. The observation gives an indication of poor pavement strength, and the possible presence of subsurface voids, leading to highly varying thickness since it is expected that strong pavement would be sufficiently and uniformly compacted with a more or less constant thickness of its layer.

Figure 6.9. Variation of pavement layer thicknesses of the runway

From all figures, it can be seen that at around 0.56-1.10 km, there is an abrupt increase in the thickness of the second layer which is an indication of weak or settled subgrade. Further performing NDT at this location has verified the existence of poor subgrade conditions. Figure 6.10 shows a part of the GPR sectional profile taken with 400 MHz antenna along L6. The pavement layers can be seen clearly and settlement of the layers can be observed at chainage of 1.196 km (encircled). This is in agreement with the sudden increase in layer thickness at this particular location as observed from Figure 6.9b.

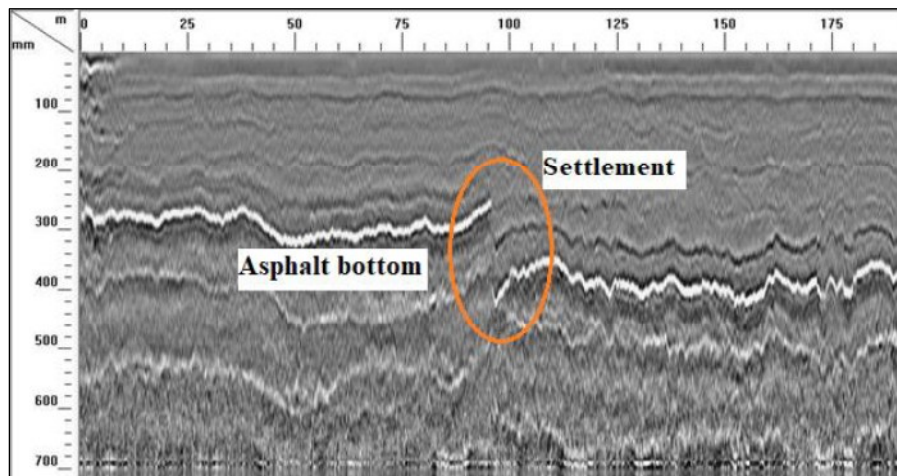
Detailed examination of GPR sectional profiles taken along the entire 3.05 km length of the runway revealed the reasons for distresses identified during the visual surveys in section 6.3 and high surface deflections reported in section 6.4 of this chapter. A GPR profile using 1500 MHz antenna along L3 from '02' end of the runway is shown in Figures 6.11 and 6.12. The bottom of the asphalt layer can be seen clearly, as indicated in Figure 6.11. Settlement of 10 cm at 95 m chainage from '02' end is also noticed. Reflection of heavy deterioration can be witnessed in Figure 6.12.

Figure 6.11. Sectional profile of runway showing asphalt layer and its settlement

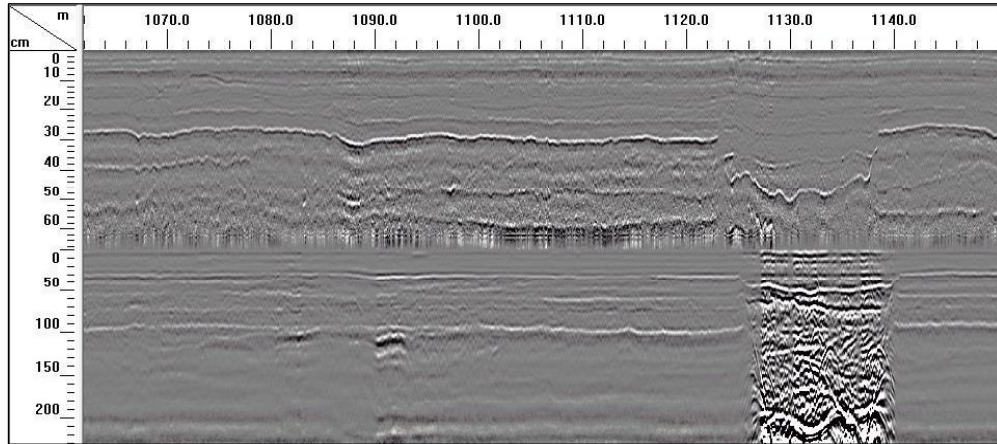
Figure 6.15. Inconsistent reflections in sectional profile of runway due to settlement of layers and their deterioration

Figure 6.13 presents GPR profile along L6 from '02' end of the runway. The data from 1500 MHz and 400 MHz antennae are integrated to apparently spot asphalt and base layer. About 30 cm settlement of base layer can be observed from 364 m to 372 m distance. Heavy deterioration and settlement are observed from Figures 6.14 and 6.15.

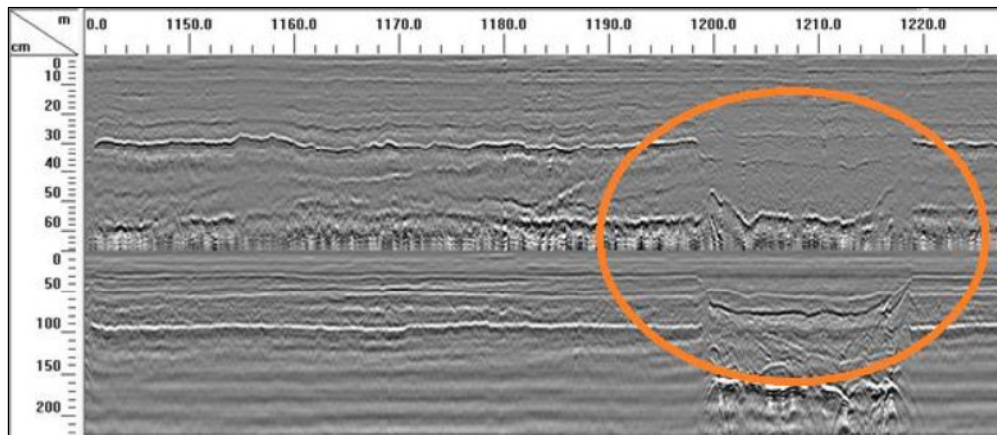
Figure 6.16 shows the settlement of layers in 1500 MHz and 400 MHz integrated GPR profile taken along R6 from '02' end of the runway.

Figure 6.16. Sectional profile of runway showing settlement of layers
